## **Slope Stability Assessment**

Proposed Residential Development  
Vacant Property  
Building Supply Road  
Burnstown, Ontario

Report: PG3155-LET.05

Subject: **Slope Stability Assessment  
Proposed Residential Development  
Vacant Property - Building Supply Road - Burnstown**

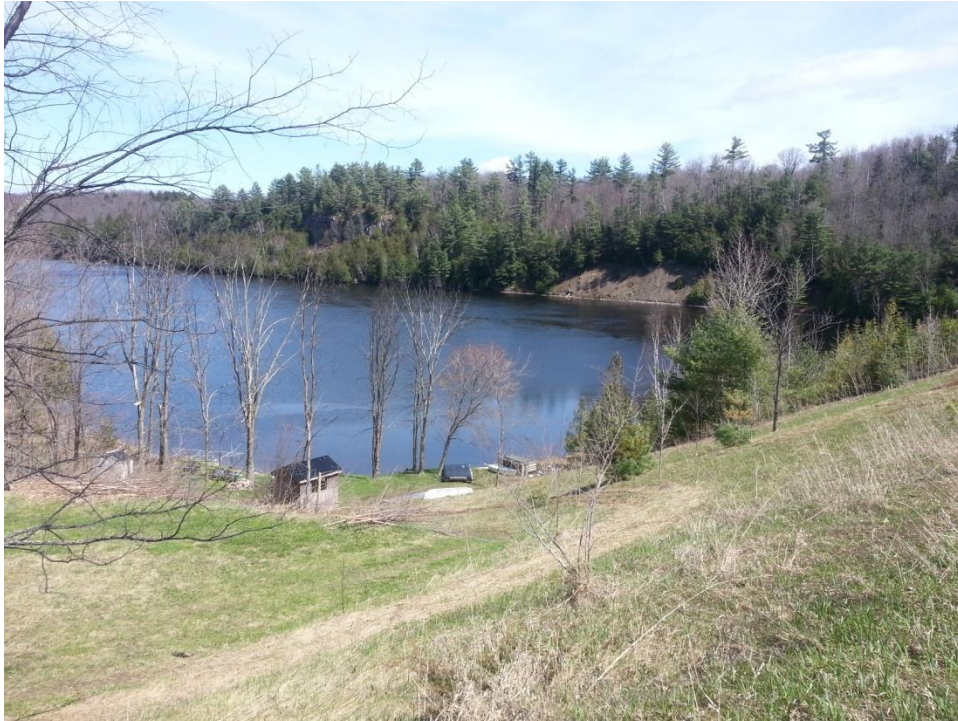
Photograph 1 – North limits of the subject site bordered by the Madawaska River.

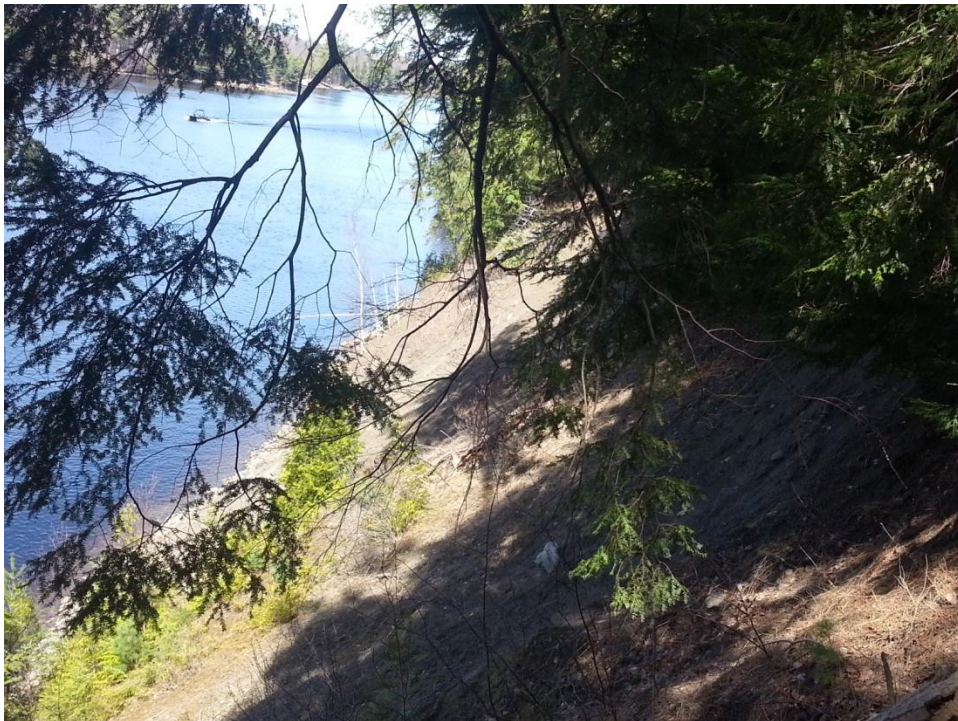
Bedrock outcrop was observed along the west and central portion of the subject slope with the exception of the area within the vicinity of Section A where an approximate 200 m wide slip failure was observed at the base of the subject slope. The remainder of the slope face and the subject site is occupied by adolescent to mature coniferous and deciduous trees. Some erosional features from the three shallow drainage swales along the slope face and minor signs of active erosion were noted along the toe of the slope along the waters edge.

Photograph 2 – Illustrates the slip failures observed along the slope face near Slope Cross Section A.

The factor of safety under static conditions was found to be less than 1.0 for Section A and therefore are considered unstable from a geotechnical perspective. Due to the current slip failures noted along the slope face within the area of Section A, subsequent slip failures are anticipated within the geotechnical set back limits which are illustrated in Figure 2a.

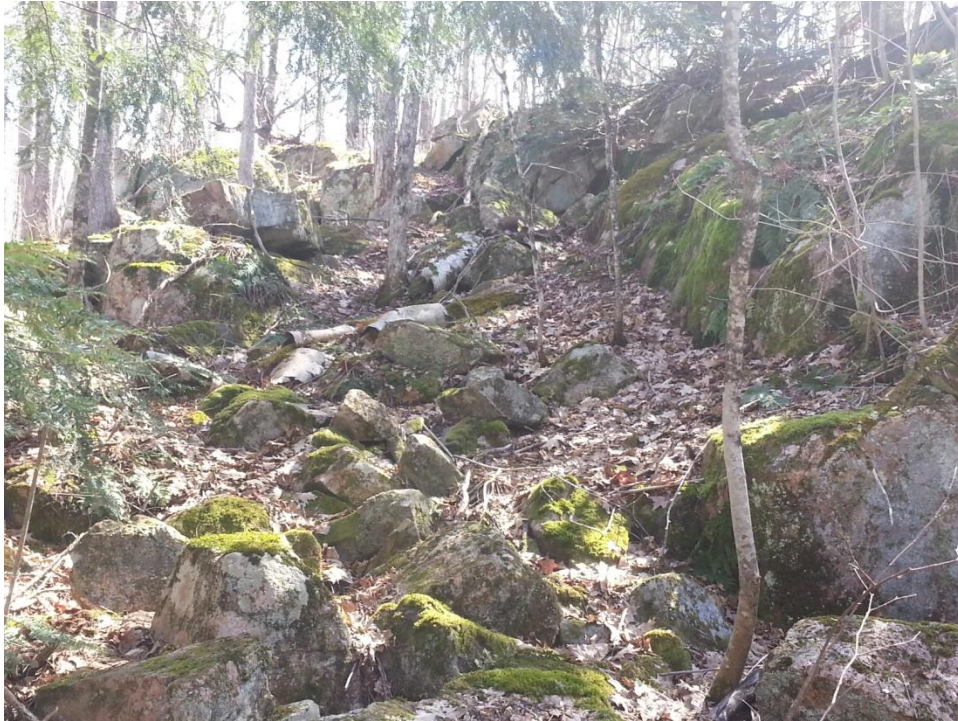
Photograph 3 – Exposed bedrock observed at several locations along the west and central portions of the subject slope

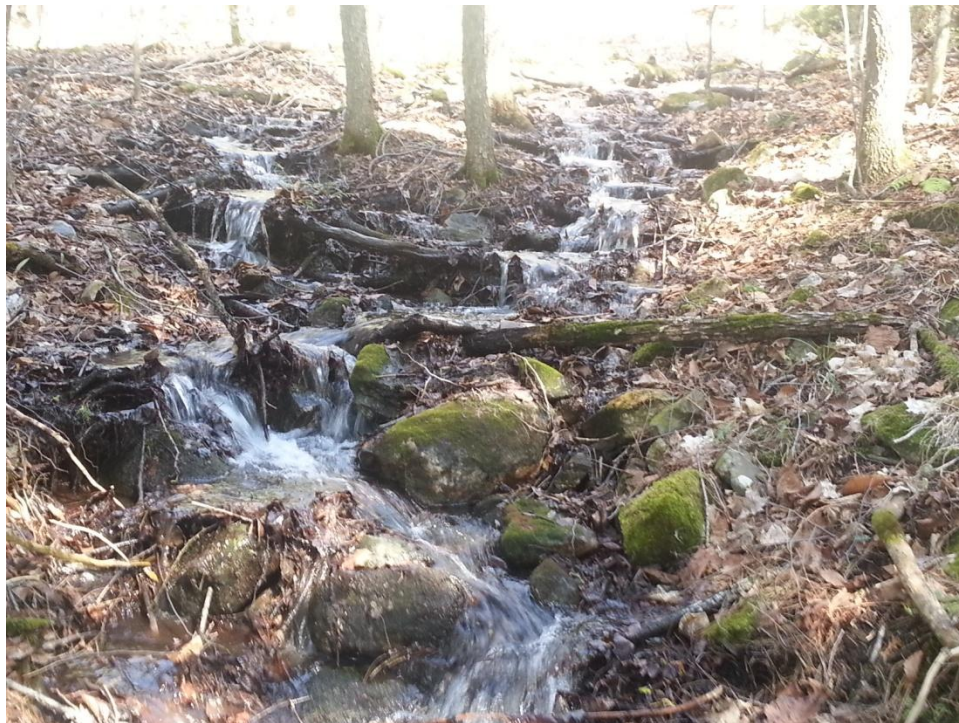
Photograph 4 – One (1) of three (3) shallow drainage streams located along the subject slope.

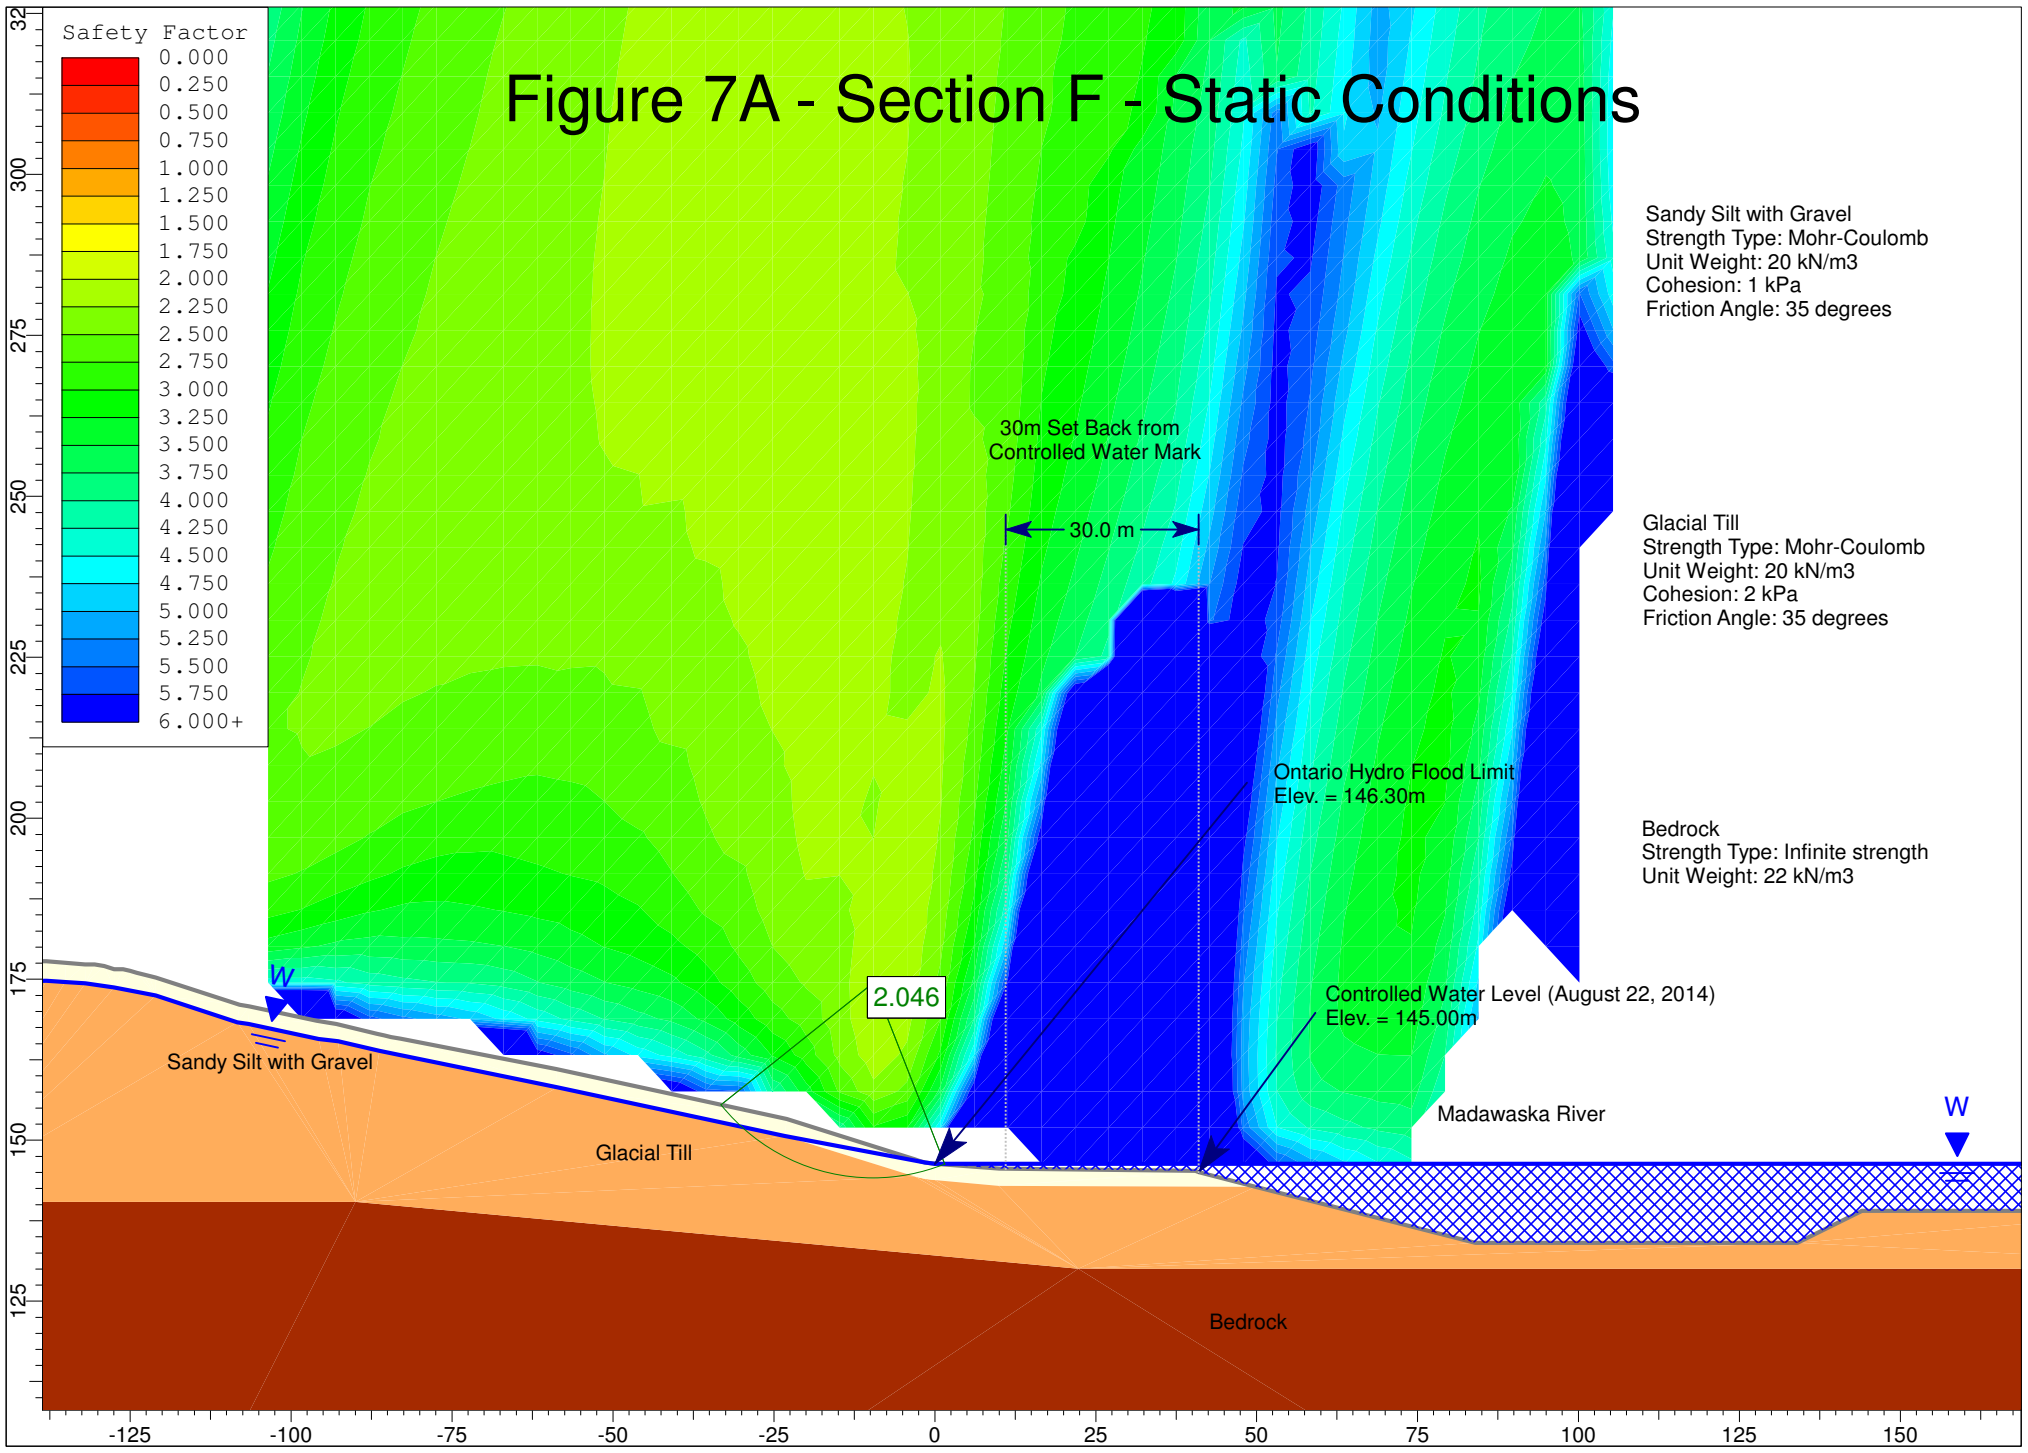
# Figure 7A - Section F - Static Conditions

The results for the slope conditions at Sections A, B, C, D, E and F are shown in Figures 2a, 3a, 4a, 5a, 6a and 7a attached to the present report. The factor of safety under static conditions was found to be less than 1.5 for all sections analysed with the exceptions of Section D, E and F which are slightly greater than the 1.5 factor of safety.

Sandy Silt with Gravel  
 Strength Type: Mohr-Coulomb  
 Unit Weight: 20 kN/m<sup>3</sup>  
 Cohesion: 1 kPa  
 Friction Angle: 35 degrees

Glacial Till  
 Strength Type: Mohr-Coulomb  
 Unit Weight: 20 kN/m<sup>3</sup>  
 Cohesion: 2 kPa  
 Friction Angle: 35 degrees
